Engineering geology study of Lingquansi Cave Temple, People's Republic of China

Abstract The Lingquansi Cave Temple, in the Henan Province of China, is a cultural heritage relic of national importance. Exquisitely cut in the rock mass, the images of Buddha in low relief, the inscriptions and the Buddhist scriptures are all stone carving art treasures of the Sui Dynasty. The cave temple was constructed on intact and compacted crystalline limestone between the fifth and tenth centuries A.R. Heavy geological deterioration and other factors have resulted in various degrees of damage to the temple's grottoes and stone carvings over the centuries such that protection and renovation are urgently required. Dazhu Grotto and the biggest and best stone carvings are the main concerns of the engineering geological study discussed here. Detailed investigations of the nature of deterioration have been carried out and proposals for remedial/preservation works are presented.

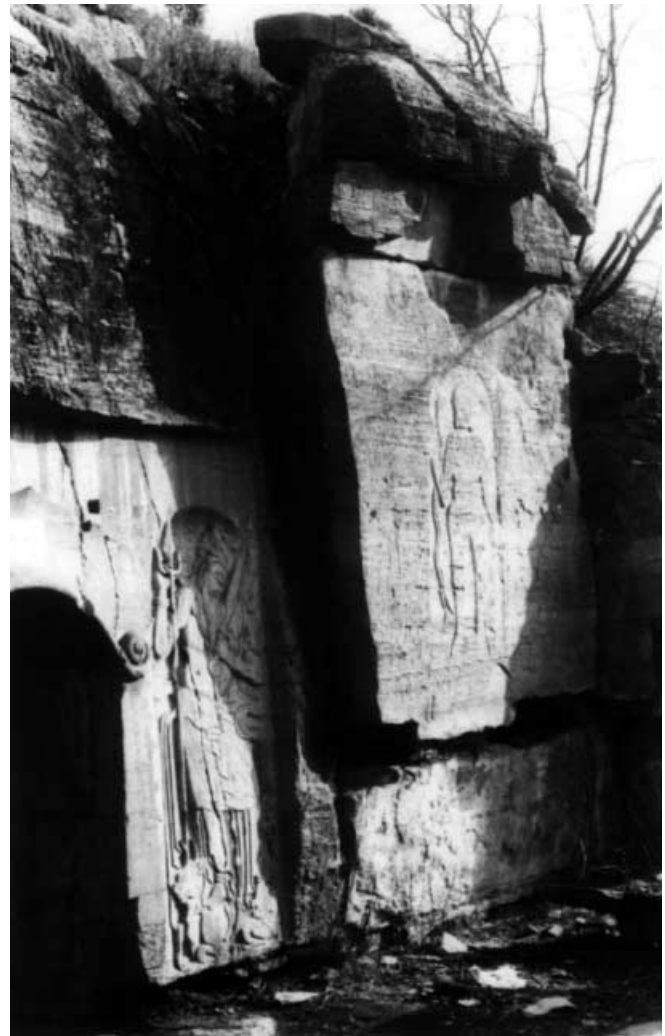
Fig. 4

From field studies it appears that the dislocations of rock blocks, dissected by many sets of structural planes, are mainly associated with earthquakes. To the east of the grotto door, for example, the rock has clearly moved towards the free face and now forms a dangerous rock mass comprising of three disconnected blocks overlapping one another (Fig. 4). From top to bottom the blocks have moved by some 200–300, 100–200 and 50–100 mm respectively. Similar features occur in the rock mass to the west. The seismic influence on the stability of the blocks, especially the already dangerous rock blocks, is therefore an important factor to take into account in the prevention and control of geological disturbances and decay.

Three disturbed blocks in Lingquansi Cave Temple study area

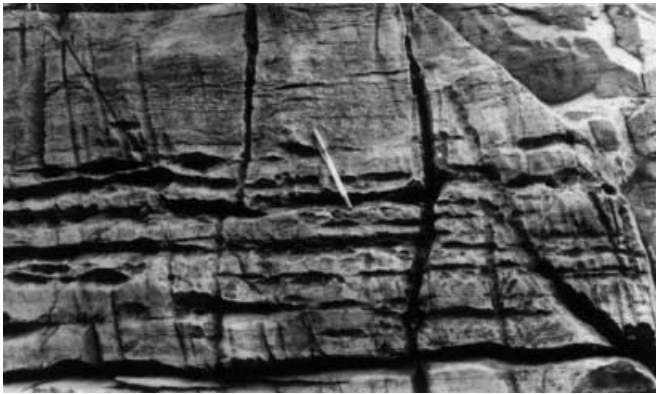
Fig. 5

bedding planes and joints in both strata (Fig. 5). Milky white and massive thickly bedded marble evidences the thermal metamorphism of the crystalline limestone. Resistance to weathering is strong.

Solution grooves well developed along bedding planes and joints in thickly bedded crystalline limestone

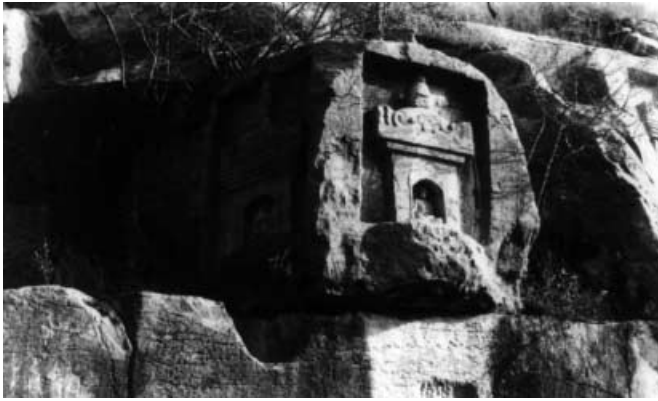
Fig. 8

Dangerous rock block in area of niches K75 and K76 of W3

A potential toppling block is present in the above-mentioned rock mass, where niches K75 and K76 are located. The crack is wider in the rear of the block and as it is connected with other structural joints, lateral water pressures will not be created. As a consequence, only the effects of earthquake loads were taken into account in the computations for the resistance of this block to toppling. As the earthquake intensity in the study area is 8° and the safety coefficient K_{RT} obtained from Eq. (3) is 2.22, it is not considered very likely that toppling would take place, even under a strong earthquake force.

- b. Rock blocks with a potential for toppling and/or collapse should be bolted to intact and stable bedrock.
 - c. Consolidation grouting and other measures should be used to reinforce wider cracks on the escarpment.
